TECH TIDBITS, vol. 14

Zinc Bromide and Bonnet Seal Bonding

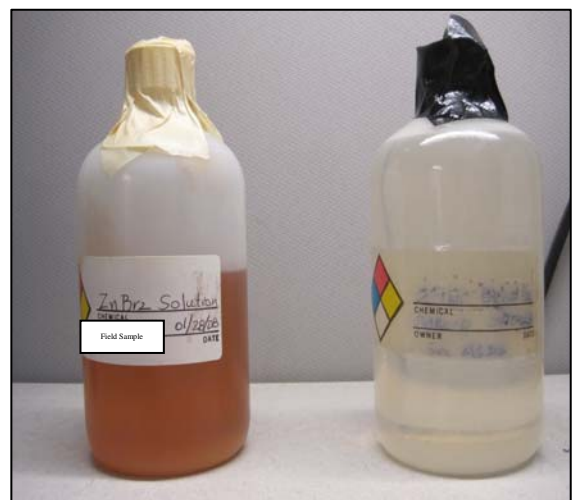
In addition to the field sample, the manufacturer acquired a "neat" sample direct from the fluid manufacturer Baroid. As can be seen in Figure 1, the two samples appear strikingly different, with the field sample being more opaque. The seal material was found to be unaffected by either sample, so the manufacturer chose to further test the adhesion of the seal rubber to the metal backup material.

Figure 1 - Zinc bromide field sample (left) with the Baroid supplied sample (right).

An additional test was requested by the operator, this time using the zinc bromide blended into the actual completion fluid on the rig. This test revealed adhesion problems between the seal rubber and the metal. This example shows that adhesion tests conducted only with "neat" $ZnBr_2$ do not reflect actual field conditions. The actual field sample contained additional additives that, when all were blended together, dissolved the adhesive. This demonstrates how completion fluid can vary in composition from well to well, and that the final, mixed fluid should be used for elastomeric studies which should also include an adhesion test.

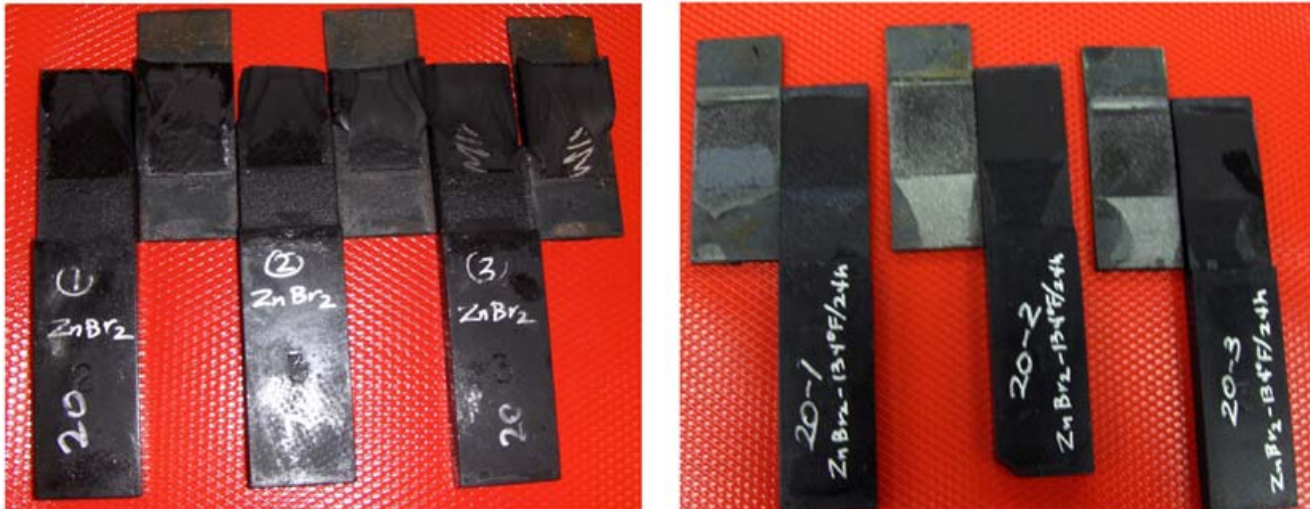
After removal, the samples were allowed to cool for 30 minutes before being tensile tested to stress the rubber-to-metal bond. As can be seen in Figure 2, the nitrile elements tested with the Baroid sample

Figure 2 – Bonding tests with Baroid sample (left) and the field sample (right)

sheared through the rubber, leaving plenty of rubber material on the metal coupon. This suggests that the metal-to-rubber bond stayed intact. However, in viewing the field sample it is obvious that the adhesive dissolved, demonstrating a total delamination of the metal from the rubber and leaving a nearly bare metal coupon.
