TECH TIDBITS, vol. 13

Ball Valves Under Pressure?

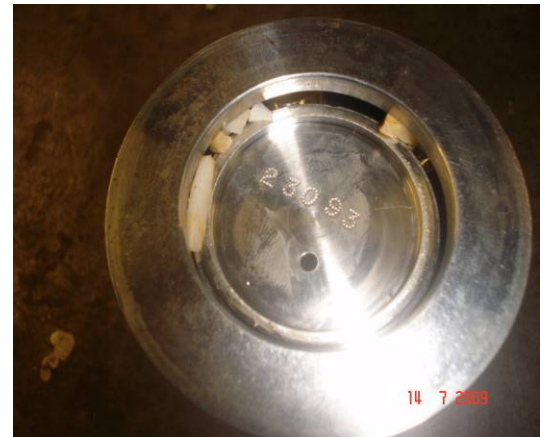
In each case, debris from damaged surface equipment, mostly ball valve seats, washed downstream through the control fluid conduit and lodged in the accumulator check valves, causing them to leak pressurized accumulator fluid (Figure 1). One case also involved a “mystery” object caught in the check valve with the broken valve seat material (Figure 2).

The ball valves were likely damaged, as often occurs, when the valve was opened. Because of high pressure behind the valve, personnel will often try to quickly crack open a ball valve, both to overcome sticking due to the static friction coefficient and to avoid seat erosion in a partially opened valve. The plastic valve seat cracks from the physical stress during the opening and/or the resulting hydraulic shock of the sudden rush of fluid.

Figure 1 – Teflon debris trapped in check valve

A high pressure filter upstream of the conduit manifold can be fitted to catch debris before it enters the check valves, regardless of the source of the debris. However, the filter doesn't address the major root cause (damage to the ball valve seats).

Another solution would be to replace the ball valve with a gate valve. The downside of this solution is that it is often expensive and also more labor intensive to operate.

The option that WEST normally recommends is to plumb a small bypass ball valve in parallel with the larger ball valve. The small valve would be opened to equalize pressure on each side before opening the main valve, to minimize the risk of seat damage.

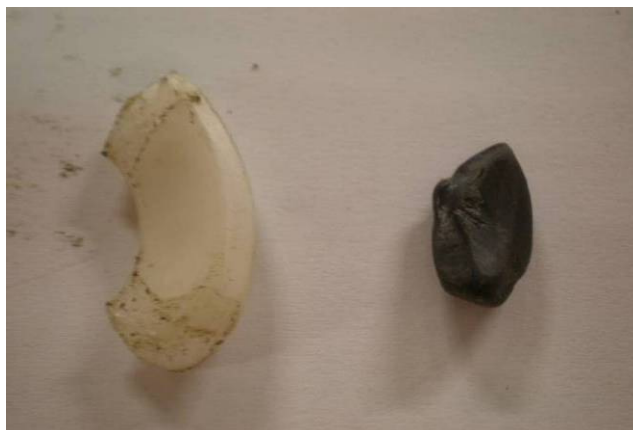
Figure 2 – Close-up of debris found in a check valve
